Manhole Inspection Summary

Manhole # S11MM_048MH

Location Address: **3013 GWYNNS FALLS PKWY** Cross Street: **LONGWOOD ST**

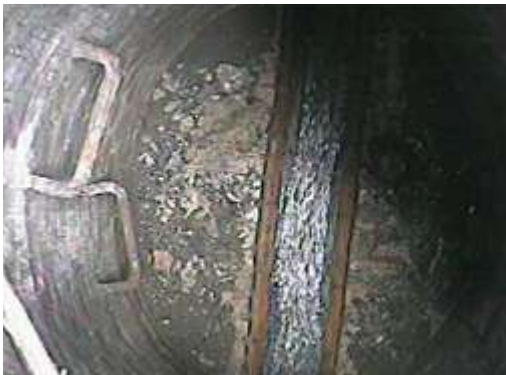
Top View

BENCH DEBRIS.

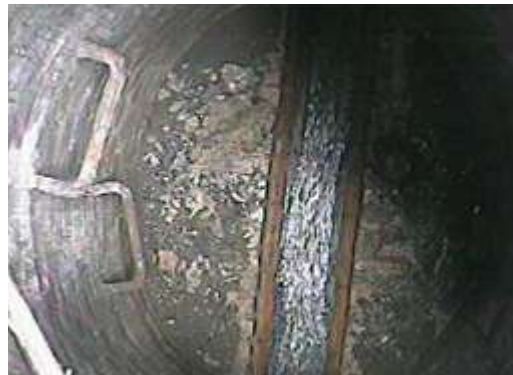
Defect 1

Steps Count: **3** Missing: **0** ☒ **Corroded**

CORRODED STEPS AND DEBRIS ON BENCH

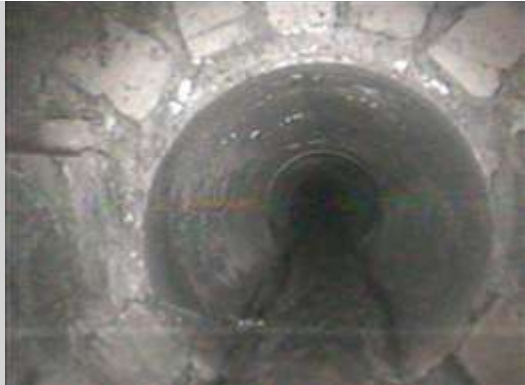
12 O'Clock Outflow

10 in. Circular Gravity Sewer
Pipe Out @ 12 O'Clock

Pipe Height: (in.) Direct
Pipe Material: **Clay** ☐ Pipe Lined
Invert Depth: **6.74** (ft.) Flow Characteristics: **Fast**
Deposits: ☒ None ☐ Mud ☐ Sludge ☐ Debris ☐ Grease
Silt Depth: (in.) Deposits Extent:
Infiltration: **None** Pipe Seal Cond: **Sound**

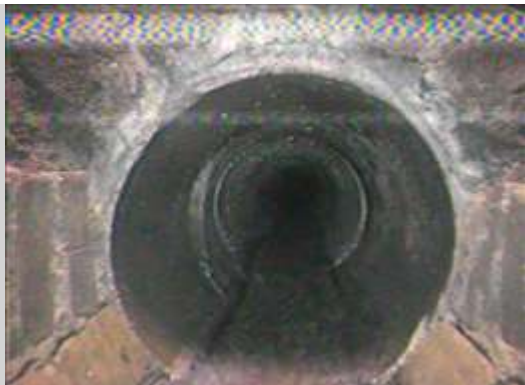
6 O'Clock Inflow

10 in. Circular Gravity Sewer
Pipe In @ 6 O'Clock

Pipe Height: (in.) Direct
Pipe Material: **Clay** ☐ Pipe Lined
Invert Depth: **6.72** (ft.) Flow Characteristics: **Fast**
Deposits: ☒ None ☐ Mud ☐ Sludge ☐ Debris ☐ Grease
Silt Depth: (in.) Deposits Extent:
Infiltration: **None** Pipe Seal Cond: **Sound**
